Mirage A3-18 Ejection 01 April 1974

FLTLT Lindsay Boyd

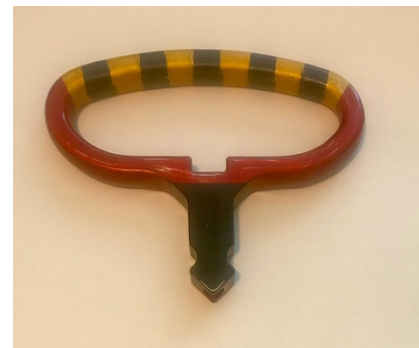
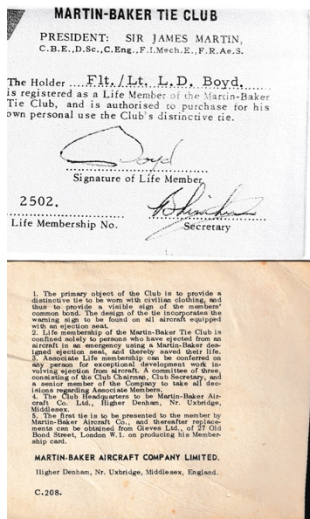
The Aircraft Accident Report stated that the compressor stall was caused by fatigue failure of a 1st stage compressor blade, possibly a manufacturing defect. After I lived to report that I had not been able to get the seat pan handle to work with my left hand checks on other aircraft revealed that a high percentage of aircraft had the same problem. The seat pan handle could not be pulled with any slant to the left. As I was in a hurry to get out, I was not aware of any requirement to make sure that I pulled it straight or with a slant to the right.

The seat pan handle had two half moon shaped cut-outs in the shaft of the handle. The cut-out on the right-hand side was engaged by the seat safety pin for the seat pan handle. The cut-out on the left-hand side of the shaft had no useful purpose. I am not sure about the truth of this but I heard that the Macchi seat (similar to the MB Mk4 in the Mirage) had been modified to eliminate this problem.
