Mirage A3-18 Ejection 01 April 1974

FLTLT Lindsay Boyd

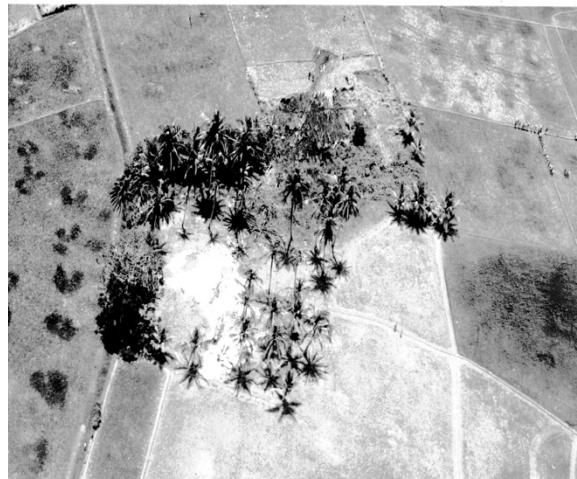
My descent profile however deteriorated and I could see that I was not going to make the runway so approaching 1000ft I called ejecting. I pulled the seat pan handle with my left hand. I had heard that it seemed a long time before the canopy and seat went but nothing was happening. I soon realized that I was about to die so I swapped hands and pulled the seat pan handle with my right hand.

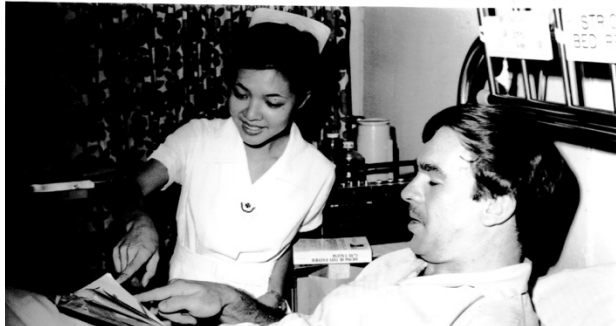
The Aircraft Accident Report says that I left the aircraft at 180ft, 160kts and a ROD 12-1500fpm. The ATC staff in the tower, who were watching the aircraft, did not

see me leave the aircraft and they were only about 3nm away. I was aware of the seat separating and one catch by the chute then I hit the ground hard in a corner of a dry paddy field close to the aircraft fireball. The SAR chopper was very quickly on the scene and took me to 4 RAAF Hospital.
